Inhibition of demand pacemaker by leakage current from electrocardiographic recorder

J. Meibom and J. Damgaard Andersen

From the Department of Medicine B, University Hospital (Rigshospitalet), Copenhagen, Denmark

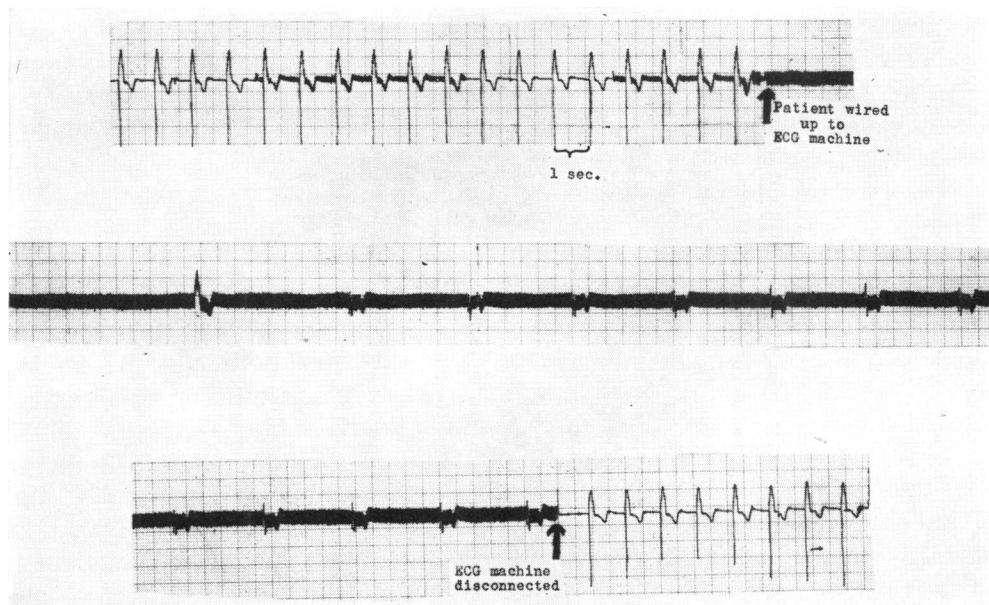
Two days after implanting the permanent pacemaker the patient fainted when he was connected to an electrocardiographic recorder for the purpose of recording a 12-lead diagnostic electrocardiogram. He was immediately disconnected and recovered in a few minutes. Since the period of asystole (as observed on a copy of the continuously recording tape, Fig. 1) seemed to be associated with the wiring up of the patient to the recorder, a careful examination of the electrical set-up and of the sensitivity of the pacemaker to external electrical influences was carried out. The patient has been followed for a year after discharge and he has not reported similar episodes during this period.

FIG. 1 Inhibition of demand pacemaker by 50 Hertz alternating current interference from electrocardiographic recorder. Relayed from continuously monitoring tape-recorder.

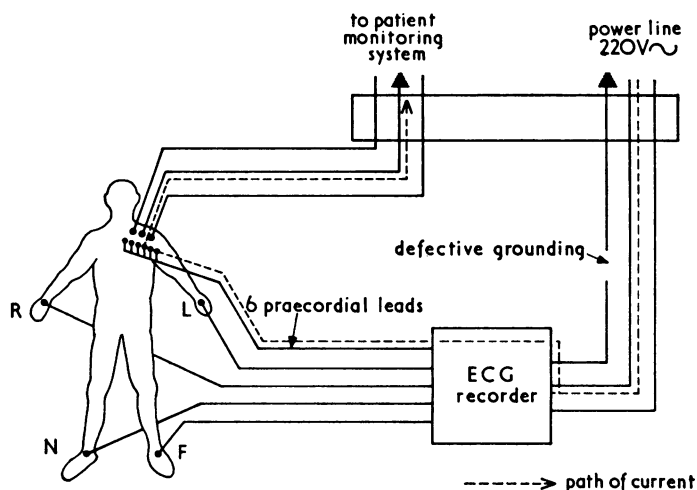
The wiring up of the patient to the electrocardiographic recorder (with power turned on) established the following current path: from the power supply outlet via the recorder through the patient and back to the power supply system ground via the central monitoring system (Fig. 2). Under normal conditions this path will carry a current less than 10 microamperes (peak-to-peak), but in this case the current was about 130 microamperes (measured with an oscilloscope connected between the monitoring system and the recorder, with the 6 praecordial and R, N, F, and L leads connected together as a common terminal). This was sufficient to arrest the im-

planted pacemaker, the threshold of inhibition later being measured to about 80 microamperes (same measuring set-up as above).

The high current passing from the recorder to the patient monitoring system was due to insufficient grounding of the electrocardiographic recorder because the ground cable in the power plug was defective. This caused the leakage current of the power cable and the recorder to flow through the patient and the monitoring system, instead of returning via the ground cable. Normally the capacitance between the windings of the power transformer in the recorder is low because a grounded shield is interposed between the windings. When grounding failed, capacitance between primary and secondary windings increased, and capacitance between power wire and ground wire in the power cable was added to this, so that the recorder acted as a current source of several megohms internal impedance. In this way, current is 'forced' through the patient, even in the presence of relatively high electrode impedances.

FIG. 2 Path of inhibiting current.

As other authors have stated (Whalen and Starmer, 1967; Weinberg, 1967), several measures can be taken in order to minimize electrical hazards, and these measures apply equally well to the care of patients with an implanted demand pacemaker. In this case we have found it important to take the following measures. (1) A technician should check the electrical equipment and installation in the

intensive care unit regularly according to a fixed schedule (visual inspection of plugs, cables, cases, etc., measurement of resistances, test of function). (2) Physicians and nurses should be educated in medical electronics, emphasizing the practical aspects: how to avoid electrical hazards and simple ways to check equipment and installation. (3) Regular checks of pacemaker function in patients suspected of carrying a demand pacemaker with

a low threshold of inhibition should be carried out.
